**Flood Control Project Maintenance  
Levee Inspections**

## Maintenance Issue Types Only, Levee Inspection Report By Mile - Spring 2018

### Reclamation District No. 0003 Grand Island

Waterway	Bank	Unit Miles	Inspection Start/End	Inspector
Unit No. 01 Left Bank Steamboat Slough	Left	10.95	04/03/2018 04/03/2018	Keith Millard

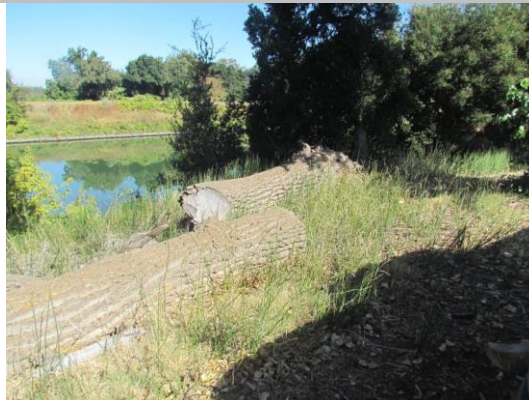
Photo 1 of 4 : SP\_2018\_RD0003\_24\_19\_20180305\_00021.jpg

LM Start	<b>0.13</b>	Rating **	M	Issue No.	<b>19 (cont)</b>
LM End	<b>0.13</b>	Issue Type +	Ma	Location *	WS

Looking north at tree branches on waterward slope. (Fall 2016)

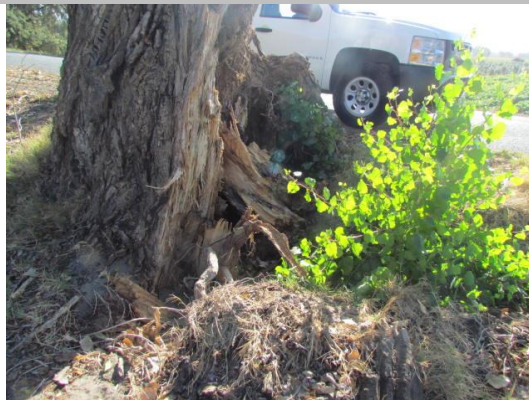
Photo 2 of 3 : SP\_2018\_RD0003\_24\_2\_20180305\_00004.jpg

LM Start	0.13	Rating **	M	Issue No.	2
LM End	0.13	Issue Type +	Ma	Location *	WS
Category	Earthen Levee			GPS Latitude/Longitude	
				Start	End
Item	Erosion / Bank Caving			38.303303 °	38.303303 °
				-121.576538 °	-121.576538 °
DWR ID	DWR_RD0003_01_f_2013_2				
Comment Code					
E2 : Schedule repair of erosion site prior to the next inspection.					
Inspector Comment					
Hole (8ft x 2.5ft x 5ft) next to a large tree on waterward shoulder.

Looking at a hole next to oak tree on waterward shoulder.(2015)

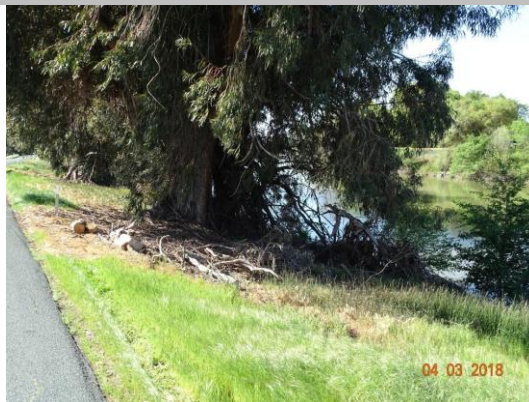
Photo 1 of 1 : SP\_2018\_RD0003\_24\_54\_20180403\_00170.jpg

LM Start	1.91	Rating **	M	Issue No.	54
LM End	1.91	Issue Type +	Ma	Location *	WS
Category	Earthen Levee			GPS Latitude/Longitude	
				Start	End
Item	Encroachments			38.280638 °	38.280638 °
				-121.588457 °	-121.588457 °
DWR ID	DWR_RD0003_01_s_2018_54				
Comment Code					
TR : Tree or limb					
Inspector Comment					
Cut branches on waterside slope and shoulder.

Cut branches on waterside slope.

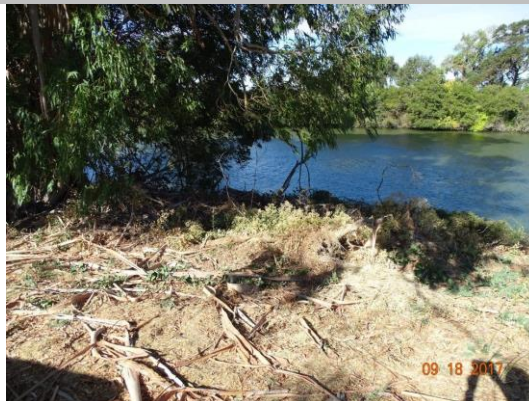
Photo 1 of 1 : SP\_2018\_RD0003\_24\_82\_20180305\_00074.jpg

LM Start	2.66	Rating **	M	Issue No.	82
LM End	2.66	Issue Type +	Ma	Location *	WS
Category	Earthen Levee			GPS Latitude/Longitude	
				Start	End
Item	Encroachments			38.271128 °	38.271128 °
				-121.588634 °	-121.588634 °
DWR ID	DWR_RD0003_01_f_2017_82				
Comment Code					
TR : Tree or limb					
Inspector Comment

Looking southwest at waterside slope.

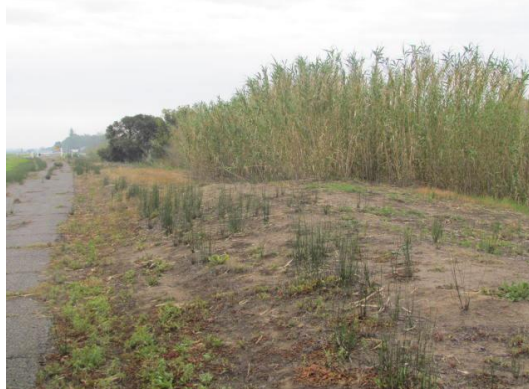
Photo 2 of 2 : SP\_2018\_RD0003\_25\_5\_20180305\_00008.jpg

LM Start	<b>0.30</b>	Rating **	M	Issue No.	<b>5 (cont)</b>
LM End	<b>0.32</b>	Issue Type +	Ma	Location *	WS

Looking east at bamboo on waterward slope. (Spring 2016)

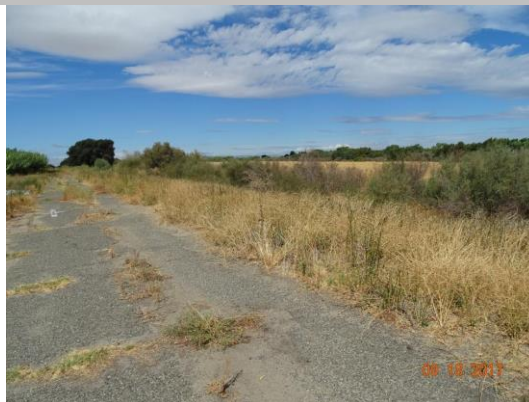
Photo 1 of 2 : SP\_2018\_RD0003\_25\_151\_20180305\_00129.jpg

LM Start	0.31	Rating **	U	Issue No.	151
LM End	0.35	Issue Type +	Ma	Location *	LS
Category	Earthen Levee			GPS Latitude/Longitude	
				Start	End
Item	Vegetation			38.174235 °	38.174109 °
				-121.648479 °	-121.647870 °
DWR ID	DWR_RD0003_02_s_2016_151				
Comment Code					
V2 : Remove the wild growth other than native grasses from the levee slopes.					
Inspector Comment					
Remove young willows along landside toe.

Looking west at landside slope.

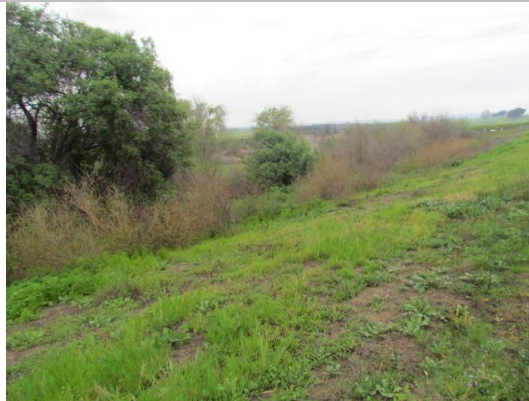
Photo 2 of 2 : SP\_2018\_RD0003\_25\_151\_20180305\_00130.jpg

LM Start	0.31	Rating **	U	Issue No.	151 (cont)	
LM End	0.35	Issue Type +	Ma	Location *	LS	
Category	Earthen Levee			GPS Latitude/Longitude		
				Start		End
Item	Vegetation			38.174235 °		38.174109 °
				-121.648479 °		-121.647870 °
DWR ID	DWR_RD0003_02_s_2016_151					
Comment Code						
V2 : Remove the wild growth other than native grasses from the levee slopes.						
Inspector Comment						
Remove young willows along landside toe.

Looking west at dense vegetation at landward toe.

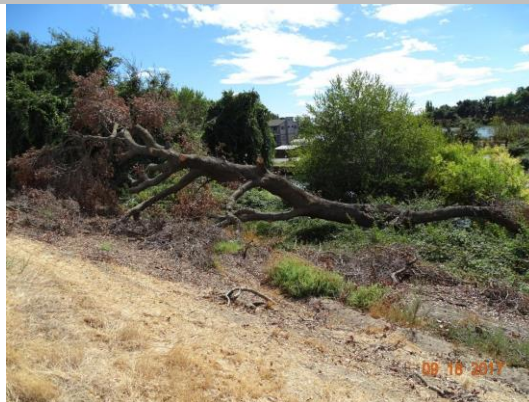
Photo 1 of 3 : SP\_2018\_RD0003\_25\_129\_20180305\_00093.jpg

LM Start	1.57	Rating **	U	Issue No.	129
LM End	1.57	Issue Type +	Ma	Location *	WS
Category	Earthen Levee			GPS Latitude/Longitude	
				Start	End
Item	Encroachments			38.168700 °	38.168700 °
				-121.627233 °	-121.627233 °
DWR ID	DWR_RD0003_02_s_2017_129				
Comment Code					
TR : Tree or limb					
Inspector Comment					
Large fallen tree on waterside slope.

Looking east at waterside slope.

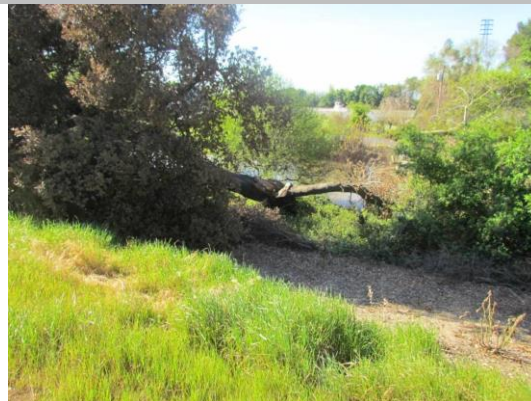
Photo 2 of 3 : SP\_2018\_RD0003\_25\_129\_20180305\_00094.jpg

LM Start	1.57	Rating **	U	Issue No.	129 (cont)	
LM End	1.57	Issue Type +	Ma	Location *	WS	
Category	Earthen Levee			GPS Latitude/Longitude		
				Start	End	
Item	Encroachments			38.168700 °	38.168700 °	
				-121.627233 °	-121.627233 °	
DWR ID	DWR_RD0003_02_s_2017_129					
Comment Code						
TR : Tree or limb						
Inspector Comment						
Large fallen tree on waterside slope.

Looking east at fallen tree on waterward slope.

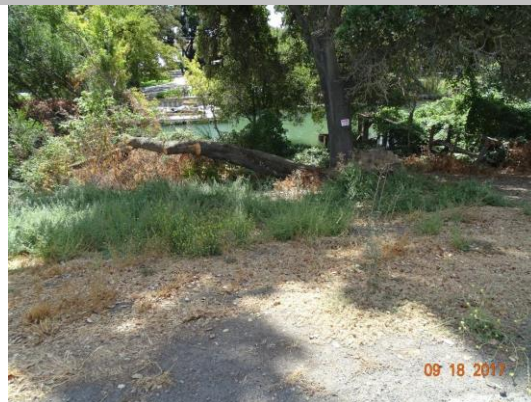
Photo 1 of 3 : SP\_2018\_RD0003\_25\_130\_20180305\_00096.jpg

LM Start	1.67	Rating **	M	Issue No.	130
LM End	1.67	Issue Type +	Ma	Location *	WS
Category	Earthen Levee			GPS Latitude/Longitude	
				Start	End
Item	Encroachments			38.167880 °	38.167880 °
				-121.625572 °	-121.625572 °
DWR ID	DWR_RD0003_02_s_2017_130				
Comment Code					
TR : Tree or limb					
Inspector Comment					
Fallen tree on waterside slope.

Looking south at the waterside slope.

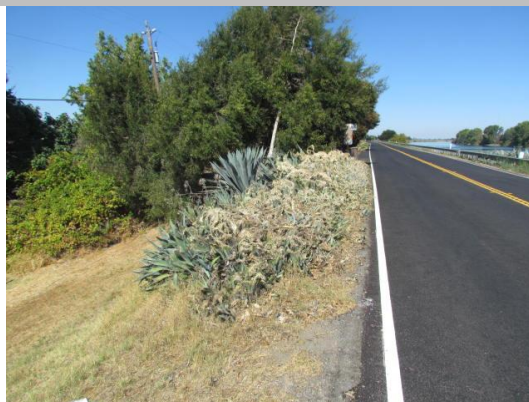
Photo 1 of 1 : SP\_2018\_RD0003\_25\_143\_20180305\_00118.jpg

LM Start	4.11	Rating **	U	Issue No.	143
LM End	4.11	Issue Type +	Ma	Location *	LS
Category	Earthen Levee			GPS Latitude/Longitude	
				Start	End
Item	Vegetation			38.178782 °	38.178782 °
				-121.590418 °	-121.590418 °
DWR ID	DWR_RD0003_02_f_2015_143				
Comment Code					
V7 : Trees / Woody Vegetation					
Inspector Comment					
Large century plants on landside shoulder and slope.

Looking north at century plants on landward shoulder and slope.

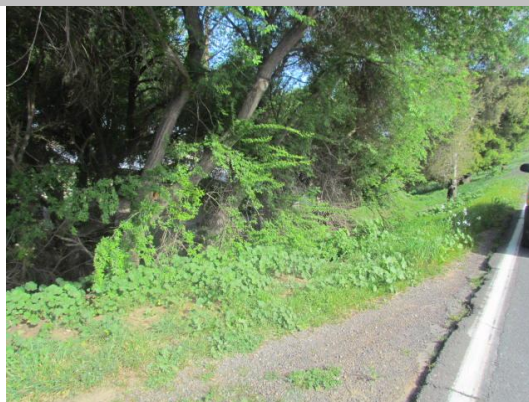
Photo 1 of 1 : SP\_2018\_RD0003\_25\_48\_20180305\_00041.jpg

LM Start	4.14	Rating **	M	Issue No.	48
LM End	4.14	Issue Type +	Ma	Location *	LS
Category	Earthen Levee			GPS Latitude/Longitude	
				Start	End
Item	Trim / Thin Trees			38.179160 °	38.179160 °
				-121.590247 °	-121.590247 °
DWR ID	DWR_RD0003_02_s_2012_48				
Comment Code					
T1 : Trim trees to at least five feet above ground level.					
Inspector Comment

Looking southwest at dense trees on landward slope.

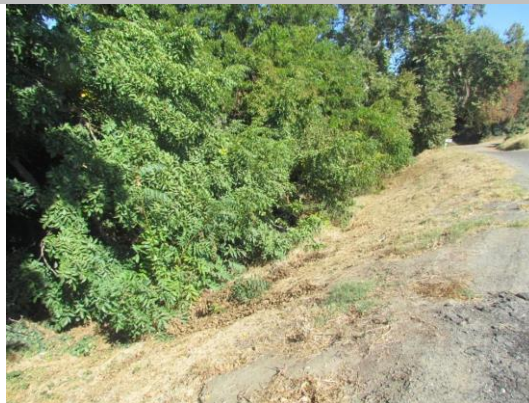
Photo 1 of 2 : SP\_2018\_RD0003\_25\_10\_20180305\_00013.jpg

LM Start	4.24	Rating **	M	Issue No.	10
LM End	4.24	Issue Type +	Ma	Location *	LS
Category	Earthen Levee			GPS Latitude/Longitude	
				Start	End
Item	Trim / Thin Trees			38.180361 °	38.180361 °
				-121.589127 °	-121.589127 °
DWR ID	DWR_RD0003_02_s_2012_10				
Comment Code					
T1 : Trim trees to at least five feet above ground level.					
Inspector Comment					
Dense untrimmed trees on landside slope and toe.

Looking north at untrimmed trees on landward slope and toe. (Fall 2016)

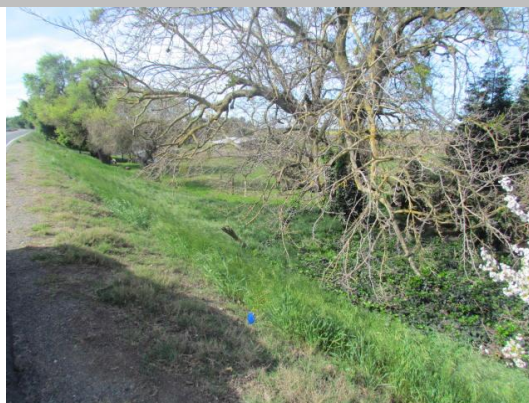
Photo 2 of 2 : SP\_2018\_RD0003\_25\_10\_20180305\_00014.jpg

LM Start	<b>4.24</b>	Rating **	M	Issue No.	<b>10 (cont)</b>
LM End	<b>4.24</b>	Issue Type +	Ma	Location *	LS

Looking west at untrimmed tree on landward slope. (Spring 2016)

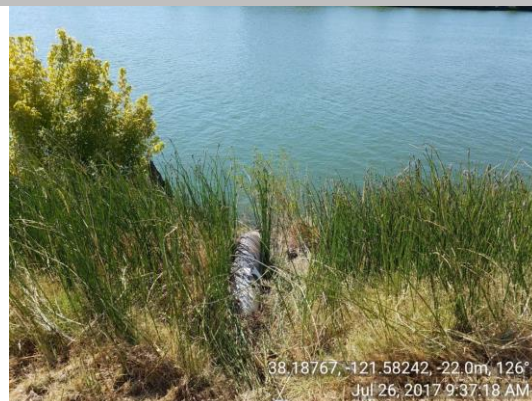
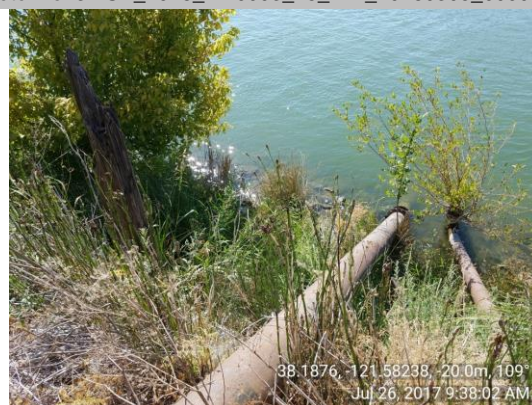
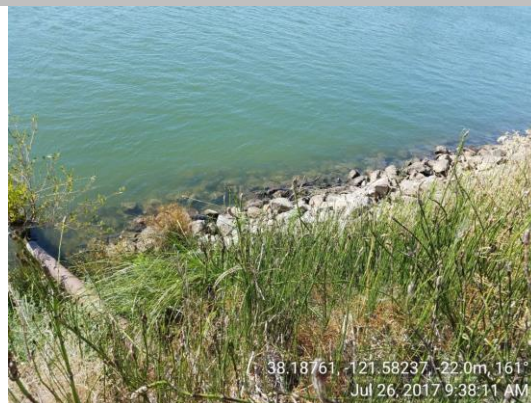
LM Start	4.86	Rating **	A/W	Issue No.	127
LM End	4.87	Issue Type +	Ma	Location *	
Category	Supplemental			GPS Latitude/Longitude	
				Start	End
Item	2017 Storm Damage			38.187528 °	38.187781 °
				-121.582394 °	-121.582331 °
DWR ID	DWR_RD0003_02_f_2017_127				
Comment Code					
Inspector Comment					
Levee Evaluation Comments					
Description: District station 256+60 to 257+96, Sec. 19, T. 4 N. R. 4 E., M.D.M. Approximately 136 linear feet erosion and sloughing exists along the water side slope of the Sacramento River (Unit 2). The erosion commences approximately 1/4 of the way down the slope from the crown and extends to the rip rap.					
Site ID No: 278					
Site Designation: LMA-104					
Repair Type: Erosion					
Rating: Area of Concern					
Field Date: 7/26/2017					
Notes:

LM Start	4.86	Rating **	A/W	Issue No.	127 (cont)	
LM End	4.87	Issue Type +	Ma	Location *		
Category	Supplemental			GPS Latitude/Longitude		
				Start	End	
Item	2017 Storm Damage			38.187528 °	38.187781 °	
				-121.582394 °	-121.582331 °	
DWR ID	DWR_RD0003_02_f_2017_127					
Comment Code						
Inspector Comment						
Levee Evaluation Comments						
Description:District station 256+60 to 257+96, Sec. 19, T. 4 N. R. 4 E., M.D.M. Approximately 136 linear feet erosion and sloughing exists along the water side slope of the Sacramento River (Unit 2). The erosion commences approximately 1/4 of the way down the slope from the crown and extends to the rip rap.						
Site ID No:278						
Site Designation:LMA-104						
Repair Type: Erosion						
Rating:Area of Concern						
Field Date:7/26/2017						
Notes:

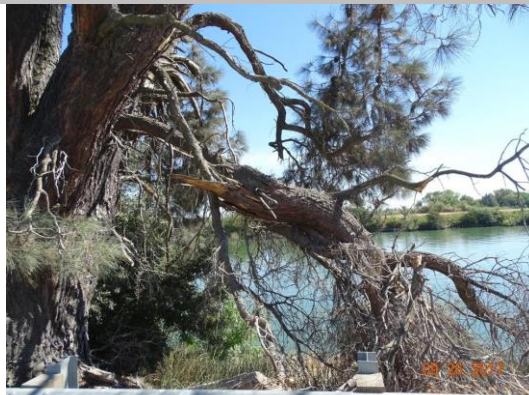
Photo 1 of 1 : SP\_2018\_RD0003\_25\_162\_20180305\_00139.jpg

LM Start	8.11	Rating **	U	Issue No.	162
LM End	8.11	Issue Type +	Ma	Location *	WS
Category	Earthen Levee			GPS Latitude/Longitude	
				Start	End
Item	Encroachments			38.224110 °	38.224110 °
				-121.557216 °	-121.557216 °
DWR ID	DWR_RD0003_02_f_2017_162				
Comment Code					
TR : Tree or limb					
Inspector Comment

Looking east at the waterside slope.

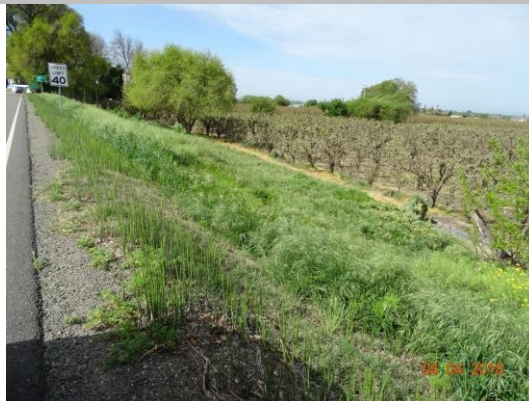
Photo 1 of 1 : SP\_2018\_RD0003\_25\_184\_20180404\_00294.jpg

LM Start	9.18	Rating **	U	Issue No.	184
LM End	9.27	Issue Type +	Ma	Location *	LS
Category	Earthen Levee			GPS Latitude/Longitude	
				Start	End
Item	Vegetation			38.238987 °	38.240126 °
				-121.558003 °	-121.557005 °
DWR ID	DWR_RD0003_02_s_2018_184				
Comment Code					
V2 : Remove the wild growth other than native grasses from the levee slopes.					
Inspector Comment

Heavy vegetation on landside slope prevents inspection.

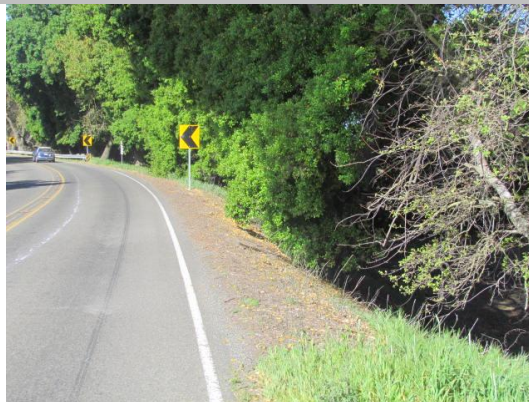
Photo 1 of 1 : SP\_2018\_RD0003\_25\_64\_20180305\_00050.jpg

LM Start	9.56	Rating **	M	Issue No.	64
LM End	9.62	Issue Type +	Ma	Location *	LS
Category	Earthen Levee			GPS Latitude/Longitude	
				Start	End
Item	Trim / Thin Trees			38.242392 °	38.242501 °
				-121.552862 °	-121.551632 °
DWR ID	DWR_RD0003_02_s_2012_64				
Comment Code					
T1 : Trim trees to at least five feet above ground level.					
Inspector Comment

Looking southwest at dense trees on landward shoulder and slope.

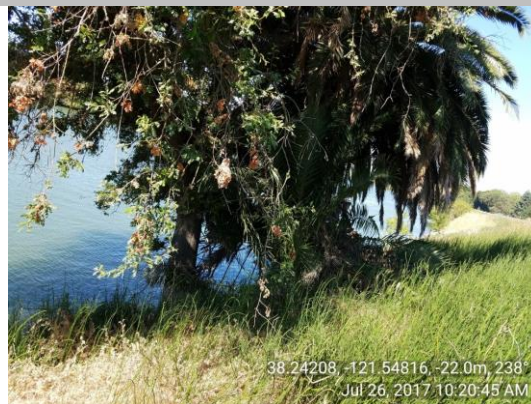
Photo 1 of 3 : SP\_2018\_RD0003\_25\_137\_20180305\_00103.jpg

LM Start	9.82	Rating **	A/W	Issue No.	137
LM End	9.84	Issue Type +	Ma	Location *	
Category	Supplemental			GPS Latitude/Longitude	
				Start	End
Item	2017 Storm Damage			38.242006 °	38.241950 °
				-121.548117 °	-121.547681 °
DWR ID	DWR_RD0003_02_f_2017_137				
Comment Code					
Inspector Comment					
Levee Evaluation Comments Description:District station 518+55 to 519+81 , Sec. 33, T. 5 N. R. 4 E., M.D.M. Approximately 126 linear feet of erosion and sloughing exists along the water side slope of the Sacramento River (Unit 2). The erosion commences approximately 1/4 of the way down the slope from the crown and extends into the rip rap. Site ID No:279 Site Designation:LMA-105 Repair Type: Erosion Rating:Area of Concern Field Date:7/26/2017 Notes:

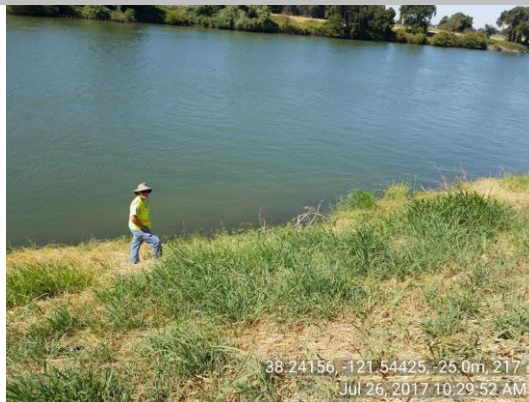
Photo 1 of 3 : SP\_2018\_RD0003\_25\_138\_20180305\_00106.jpg

LM Start	10.01	Rating **	A/W	Issue No.	138
LM End	10.03	Issue Type +	Ma	Location *	
Category	Supplemental			GPS Latitude/Longitude	
				Start	End
Item	2017 Storm Damage			38.241481 °	38.241439 °
				-121.544569 °	-121.544353 °
DWR ID	DWR_RD0003_02_f_2017_138				
Comment Code					
Inspector Comment					
Levee Evaluation Comments					
Description:District station 528+97 to 529+58, Sec. 33, T. 5 N. R. 4 E., M.D.M. Approximately 61 linear feet of erosion and sloughing exists along the water side slope of the Sacramento River (Unit 2). The erosion commences approximately 1/2 of the way down the slope from the crown and extends into the rip rap.					
Site ID No:280					
Site Designation:LMA-106					
Repair Type: Erosion					
Rating:Area of Concern					
Field Date:7/26/2017					
Notes:

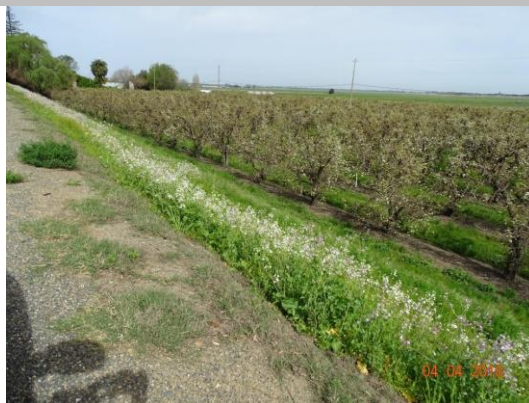
Photo 1 of 1 : SP\_2018\_RD0003\_25\_167\_20180404\_00295.jpg

LM Start	10.20	Rating **	U	Issue No.	167
LM End	10.48	Issue Type +	Ma	Location *	LS
Category	Earthen Levee			GPS Latitude/Longitude	
				Start	End
Item	Vegetation			38.240938 °	38.239695 °
				-121.541251 °	-121.536265 °
DWR ID	DWR_RD0003_02_s_2018_167				
Comment Code					
V1 : Control annual grass and weeds on the levee slopes and easements.					
Inspector Comment

Heavy vegetation on Inside slope prevents inspection.

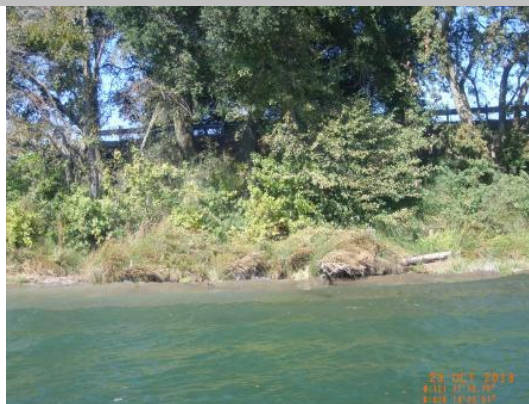
Photo 1 of 2 : SP\_2018\_RD0003\_25\_1\_20180305\_00001.jpg

LM Start	11.33	Rating **	A/W	Issue No.	1
LM End	11.42	Issue Type +	Ma	Location *	WS
Category	Supplemental			GPS Latitude/Longitude	
				Start	End
Item	2015 USACE Erosion Survey, DRAFT			38.239870 °	38.239983 °
				-121.520989 °	-121.519361 °
DWR ID	DWR_RD0003_02_s_2016_1				
Comment Code					
Inspector Comment					
2009 - Hole left in levee toe from a fallen tree. Could be repaired under maintenance. 2010 - Minor new erosion. 2015: Minor new erosion at toe. [2015 Site ID: SAC_26-3_R]

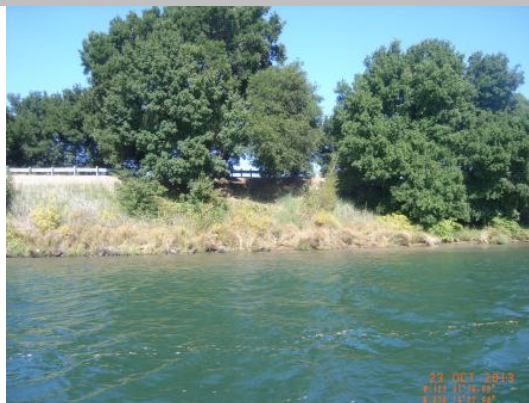
Photo 2 of 2 : SP\_2018\_RD0003\_25\_1\_20180305\_00002.jpg

LM Start	11.33	Rating **	A/W	Issue No.	1 (cont)	
LM End	11.42	Issue Type +	Ma	Location *	WS	
Category	Supplemental			GPS Latitude/Longitude		
				Start		End
Item	2015 USACE Erosion Survey, DRAFT			38.239870 °		38.239983 °
				-121.520989 °		-121.519361 °
DWR ID	DWR_RD0003_02_s_2016_1					
Comment Code						
Inspector Comment						
2009 - Hole left in levee toe from a fallen tree. Could be repaired under maintenance. 2010 - Minor new erosion. 2015: Minor new erosion at toe. [2015 Site ID: SAC_26-3_R]

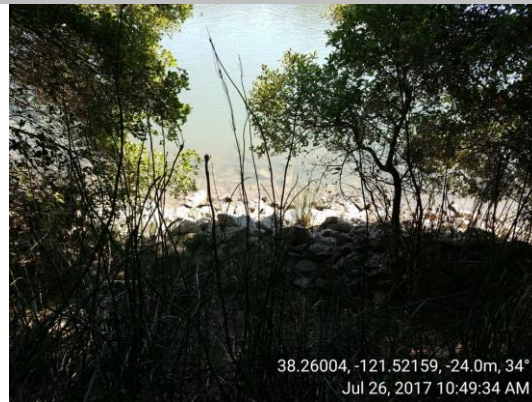
Photo 1 of 3 : SP\_2018\_RD0003\_25\_139\_20180305\_00109.jpg

LM Start	13.15	Rating **	A/W	Issue No.	139
LM End	13.17	Issue Type +	Ma	Location *	
Category	Supplemental			GPS Latitude/Longitude	
				Start	End
Item	2017 Storm Damage			38.260042 °	38.260219 °
				-121.521581 °	-121.521803 °
DWR ID	DWR_RD0003_02_f_2017_139				
Comment Code					
Inspector Comment					
Levee Evaluation Comments					
Description:District station 694+80 to 695+69, Sec. 27, 1. 5 N. R. 4 E., M.D.M. Approximately 89 linear feet of erosion and sloughing exists along the water side slope of the Sacramento River (Unit 2). The erosion commences approximately 1/2 of the way down the slope from the crown and extends into the rip rap.					
Site ID No:281					
Site Designation:LMA-107					
Repair Type: Erosion					
Rating:Area of Concern					
Field Date:7/26/2017					
Notes:

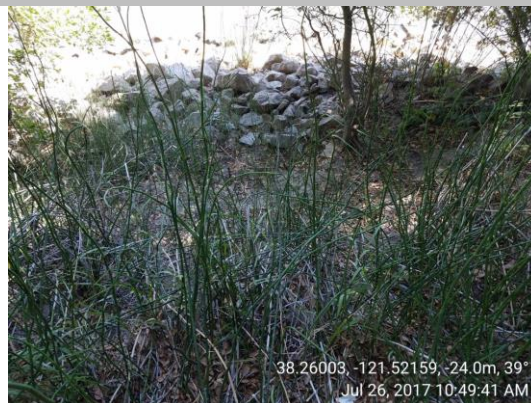
Photo 2 of 3 : SP\_2018\_RD0003\_25\_139\_20180305\_00110.jpg

LM Start	13.15	Rating **	A/W	Issue No.	139 (cont)	
LM End	13.17	Issue Type +	Ma	Location *		
Category	Supplemental			GPS Latitude/Longitude		
				Start	End	
Item	2017 Storm Damage			38.260042 °	38.260219 °	
				-121.521581 °	-121.521803 °	
DWR ID	DWR_RD0003_02_f_2017_139					
Comment Code						
Inspector Comment						
Levee Evaluation Comments						
Description:District station 694+80 to 695+69, Sec. 27, 1. 5 N. R. 4 E., M.D.M. Approximately 89 linear feet of erosion and sloughing exists along the water side slope of the Sacramento River (Unit 2). The erosion commences approximately 1/2 of the way down the slope from the crown and extends into the rip rap.						
Site ID No:281						
Site Designation:LMA-107						
Repair Type: Erosion						
Rating:Area of Concern						
Field Date:7/26/2017						
Notes:

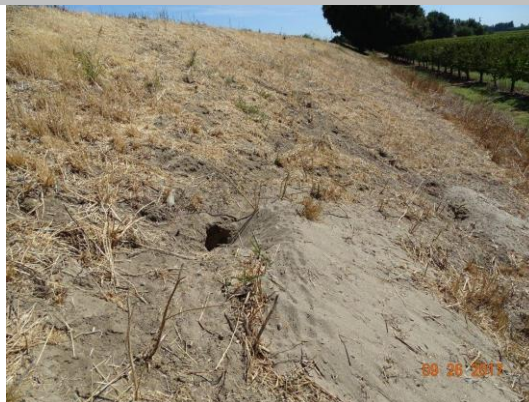
Photo 1 of 1 : SP\_2018\_RD0003\_25\_169\_20180305\_00143.jpg

LM Start	<b>13.86</b>	Rating **	M	Issue No.	<b>169</b>
LM End	<b>13.86</b>	Issue Type +	Ma	Location *	LS
Category	Earthen Levee		GPS Latitude/Longitude		
			Start	End	
Item	Animal Control		38.267084 °	38.267084 °	
			-121.530939 °	-121.530939 °	
DWR ID	DWR_RD0003_02_f_2017_169				
Comment Code					
A1 : Exterminate rodents and backfill and compact or grout burrows.					
Inspector Comment

Looking southeast at the landside slope.

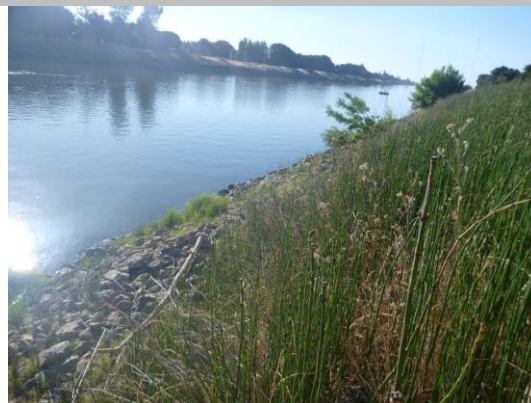
Photo 1 of 3 : SP\_2018\_RD0003\_25\_142\_20180305\_00115.jpg

LM Start	15.00	Rating **	A/W	Issue No.	142
LM End	15.07	Issue Type +	Ma	Location *	
Category	Supplemental			GPS Latitude/Longitude	
				Start	End
Item	2017 Storm Damage			38.278806 °	38.279444 °
				-121.545817 °	-121.546647 °
DWR ID	DWR_RD0003_02_f_2017_142				
Comment Code					
Inspector Comment					
Levee Evaluation Comments					
Description:District station 792+44 to 795+74, Sec. 16, T. 5 N. R. 4 E., M.D.M. Approximately 330 linear feet of erosion and sloughing exists along the water side slope of the Sacramento River (Unit 2). The erosion commences approximately 1/2 of the way down the slope from the crown and extends into the rip rap.					
Site ID No:282					
Site Designation:LMA-108					
Repair Type: Erosion					
Rating:Area of Concern					
Field Date:7/28/2017					
Notes: no berm

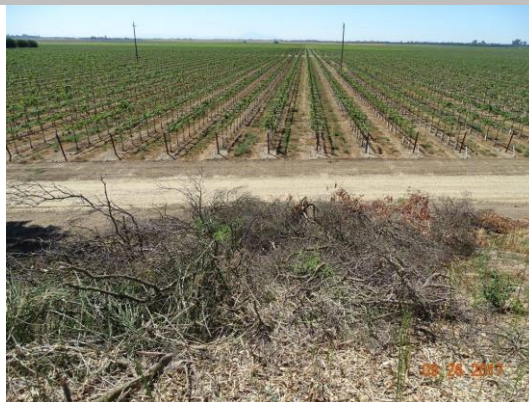
Photo 1 of 3 : SP\_2018\_RD0003\_25\_134\_20180305\_00100.jpg

LM Start	15.37	Rating **	M	Issue No.	134
LM End	15.37	Issue Type +	Ma	Location *	LS
Category	Earthen Levee			GPS Latitude/Longitude	
				Start	End
Item	Encroachments			38.282243 °	38.282243 °
				-121.550917 °	-121.550917 °
DWR ID	DWR_RD0003_02_s_2017_134				
Comment Code					
PR : Prunings					
Inspector Comment					
Large fallen tree on landside slope. Large tree removed, prunings remain on slope.

Looking southwest at the landside slope.

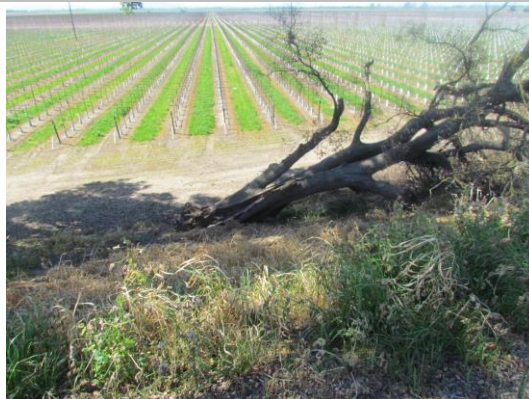
Photo 2 of 3 : SP\_2018\_RD0003\_25\_134\_20180305\_00101.jpg

LM Start	15.37	Rating **	M	Issue No.	134 (cont)	
LM End	15.37	Issue Type +	Ma	Location *	LS	
Category	Earthen Levee			GPS Latitude/Longitude		
				Start		End
Item	Encroachments			38.282243 °		38.282243 °
				-121.550917 °		-121.550917 °
DWR ID	DWR_RD0003_02_s_2017_134					
Comment Code						
PR : Prunings						
Inspector Comment						
Large fallen tree on landside slope. Large tree removed, prunings remain on slope.

Looking west at fallen tree at landward toe.

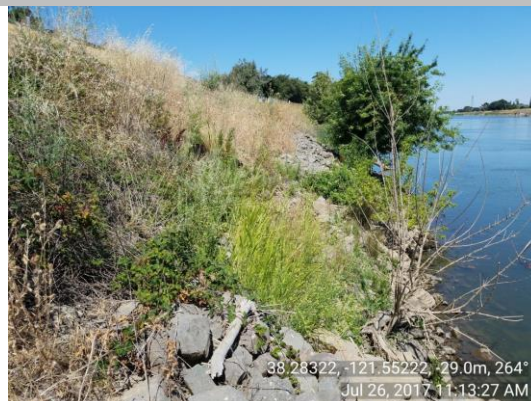
Photo 1 of 3 : SP\_2018\_RD0003\_25\_149\_20180305\_00124.jpg

LM Start	15.46	Rating **	A/W	Issue No.	149
LM End	15.47	Issue Type +	Ma	Location *	
Category	Supplemental			GPS Latitude/Longitude	
				Start	End
Item	2017 Storm Damage			38.283119 °	38.283172 °
				-121.552250 °	-121.552347 °
DWR ID	DWR_RD0003_02_f_2017_149				
Comment Code					
Inspector Comment					
Levee Evaluation Comments					
Description:District station 816+64 to 816+97, Sec. 16, T. 5 N. R. 4 E., M.D.M. Approximately 33 linear feet of erosion exists along the water side slope of the Sacramento River (Unit 2). The erosion commences approximately 1/2 ofthe way down the slope from the crown and extends into the rip rap. A section of rip rap has eroded away in this location.					
Site ID No:283					
Site Designation:LMA-109					
Repair Type: Erosion					
Rating:Area of Concern					
Field Date:7/26/2017					
Notes:

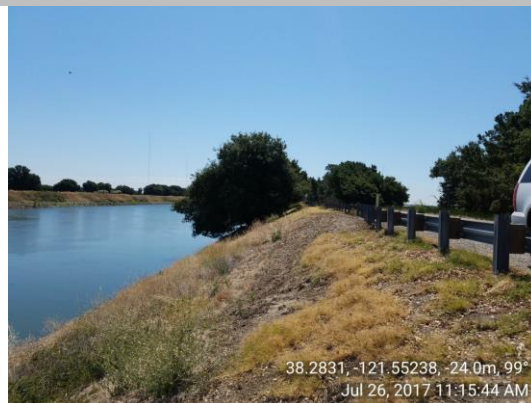
Photo 3 of 3 : SP\_2018\_RD0003\_25\_149\_20180305\_00126.jpg

LM Start	15.46	Rating **	A/W	Issue No.	149 (cont)
LM End	15.47	Issue Type +	Ma	Location *	
Category	Supplemental			GPS Latitude/Longitude	
				Start	End
Item	2017 Storm Damage			38.283119 °	38.283172 °
				-121.552250 °	-121.552347 °
DWR ID	DWR_RD0003_02_f_2017_149				
Comment Code					
Inspector Comment					
Levee Evaluation Comments					
Description:District station 816+64 to 816+97, Sec. 16, T. 5 N. R. 4 E., M.D.M. Approximately 33 linear feet of erosion exists along the water side slope of the Sacramento River (Unit 2). The erosion commences approximately 1/2 ofthe way down the slope from the crown and extends into the rip rap. A section of rip rap has eroded away in this location.					
Site ID No:283					
Site Designation:LMA-109					
Repair Type: Erosion					
Rating:Area of Concern					
Field Date:7/26/2017					
Notes:

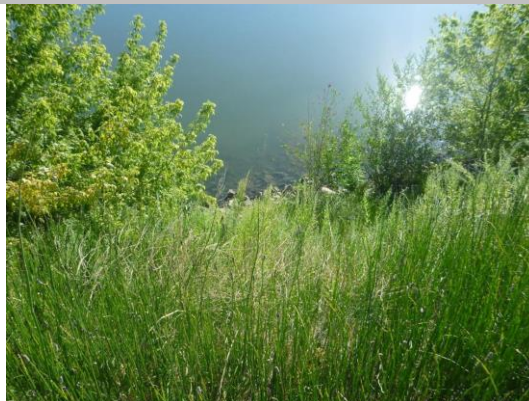
Photo 1 of 2 : SP\_2018\_RD0003\_25\_150\_20180305\_00127.jpg

LM Start	<b>16.54</b>	Rating **	A/W	Issue No.	<b>150</b>
LM End	<b>16.56</b>	Issue Type +	Ma	Location *	
Category	Supplemental		GPS Latitude/Longitude		
			Start	End	
Item	2017 Storm Damage		38.294717 °	38.294986 °	
			-121.565417 °	-121.565661 °

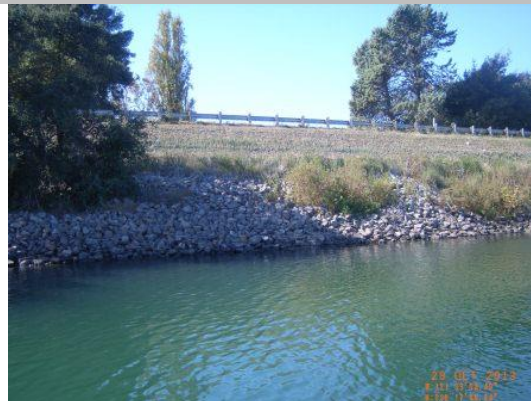
Photo 1 of 1 : SP\_2018\_RD0003\_25\_20\_20180305\_00027.jpg

LM Start	16.54	Rating **	A/W	Issue No.	20
LM End	16.63	Issue Type +	Ma	Location *	WS
Category	Supplemental			GPS Latitude/Longitude	
				Start	End
Item	2015 USACE Erosion Survey, DRAFT			38.294757 °	38.295730 °
				-121.565376 °	-121.566295 °
DWR ID	DWR_RD0003_02_s _ 2016_20				
Comment Code					
Inspector Comment					
1997 - Erosion of supper sandy levee material above the water line, straight reach. 1999 - Small pocket repaired with rock. 2005 - Downstream 400 ft have been repaired. 2011 - Site is overgrown with vegetation. 2015: Site appears stable, may consider removal if no change after the next large storm event. [2015 Site ID: SAC_31-6_R]

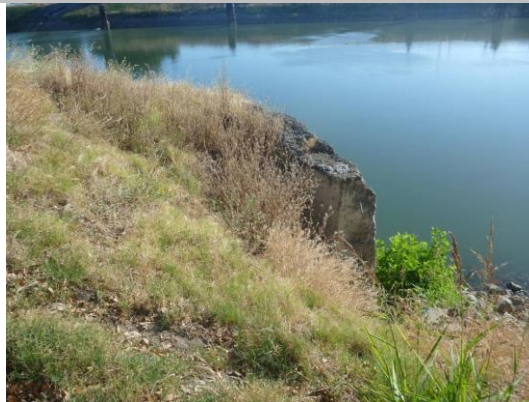
Photo 1 of 3 : SP\_2018\_RD0003\_25\_152\_20180305\_00131.jpg

LM Start	16.90	Rating **	A/W	Issue No.	152
LM End	16.90	Issue Type +	Ma	Location *	
Category	Supplemental			GPS Latitude/Longitude	
				Start	End
Item	2017 Storm Damage			38.298914 °	38.298997 °
				-121.569156 °	-121.569217 °
DWR ID	DWR_RD0003_02_f_2017_152				
Comment Code					
Inspector Comment					
Levee Evaluation Comments					
Description:District station 892+36 to 892+70, Sec. 08, T. 5 N. R. 4 E., M.D.M. Approximately 34 linear feet of erosion exists along the water side slope of the Sacramento River (Unit 2). The erosion commences approximately 1/2 of the way down the slope from the crown and extends into the rip rap. A section of rip rap has eroded away in this location.					
Site ID No:285					
Site Designation:LMA-111					
Repair Type: Erosion					
Rating:Area of Concern					
Field Date:7/28/2017					
Notes: highway on crown
